L3 "FULL SPEED AHEAD" Project

Roger Himka April , 2017

L3 Troubleshooting History

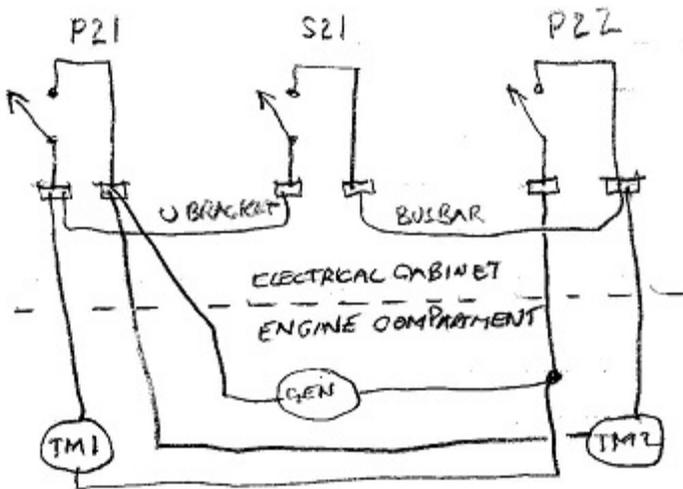
There is a difference in power wiring between engine 1 and engine 2. Engine 1 has three cables on the front connection - engine 2 only has two. The only way to track the cables (if necessary) will be to disconnect them from the contactors. There is a difference in apparent load on the switching system. The open load on all three engine 1 contactors (P1, P2, S1) is 1.7 ohms. The open load on all three engine 2 contactors (P21, P22, S21) is only about 0.9 ohms. Given the inaccuracy of measurements of small resistances, it has the appearance of one having serial traction motors, the other having parallel traction motors - strange.

Also noted - needing repair - there is a return spring on contactor S21 that is hanging loose. I didn't determine whether it was intentionally disconnected, or there was a failure. The corresponding spring in contactor S1 is in place. The power contactor circuitry does not match the diagram. The diagram has Transition contactors (T1 and T2) - they don't physically exist. The diagram has two Serial contactors for each engine, only one each exists. The Serial contactor that exists is labelled S1 (and S21) - but has the function of the contactor labelled S2 in the diagram. A probable diagram for the load switching has been sketched, but requires the assumption of a connection between one of the traction motors and the generator at a location not in the electrical cabinet (for example, directly connected at the generator output).

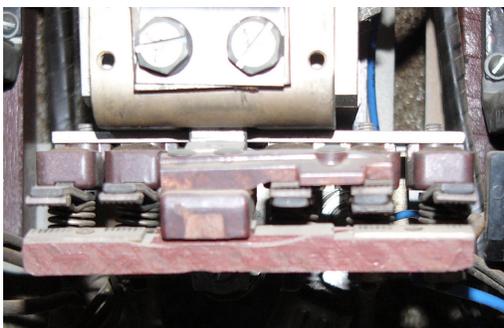
Tracing the wiring from P22 coil lead to P21 auxiliary contacts terminal 5. When P21 is activated, the P21 coil is supposed to be connected to P21 aux terminal 4, which in turn is connected to in-run battery power (throttle to run 1 or higher). There is no apparent adjustment for contact separation. The lack of contact is caused by the horizontal bar containing the shorting plate not fully rising to contacts 4 and 5. The bar is rivetted to the actuator arm, and the assembly is worn such that the horizontal bar twists rather than fully rising. Since this wiring goes through safety

interlocks (such as ground fault), I needed to have some confidence that jumpering P21 aux term 5 directly to in-run batter power would not cause a safety issue. Normally, when ground fault is activated, P21 is de-activated, which in turn would de-activate P22. With the proposed jumper, P22 would remain activated with a ground fault, but since P1 would be de-activated, there would be no power to the motors, so jumpering P21 directly to in-run power appears to be safe.

Since the active configuration of the GF contactors matched for serial and parallel, it was assumed (hoped) that adding the jumper from P21 terminal 4 to P21 terminal 5 and a jumper from P21 terminal 5 to V21 terminal 3 (power when in run) should be safe. As with engine 1, the wire from P21 terminal 3 to the coil of S21 was disconnected and taped to prevent any accidental activation of S21. When the engines were started, they both activated to parallel and both loaded. Time for a road test.

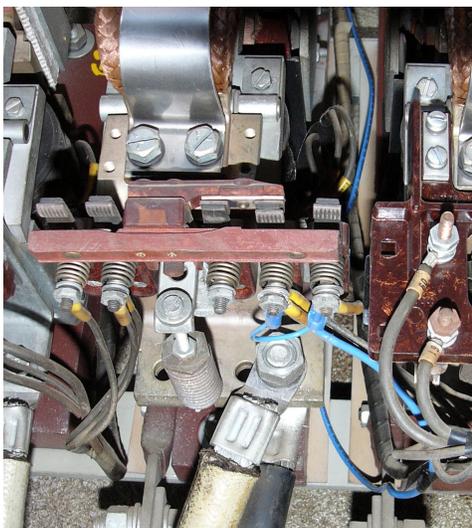
NOTE: Unconnected ring terminal (to ?) Left of V21

Revise P21 auxiliary contacts

Disconnect wire from terminal 3 (on bottom, goes to S21 coil) and tape

Connect (blue jumper) terminal 4 to terminal 5

Connect (blue jumper) terminal 5 to V21 terminal 3
